DOE/NV--1170

Amchitka Mud Pit Sites 2006 Post-Closure Monitoring and Inspection Report Amchitka Island, Alaska

September 2006

Prepared by Stoller-Navarro Joint Venture

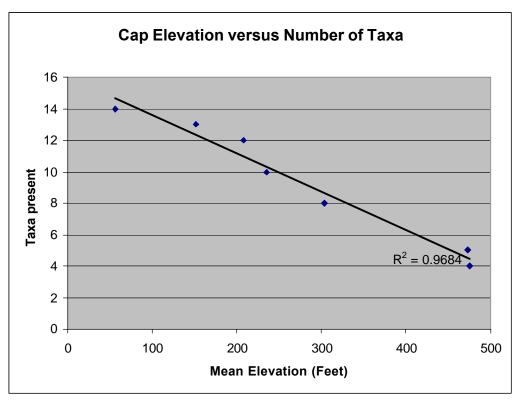
Figure 2.4

Species diversity showed inverse correlation with cap elevation (Figure 2.4). Cap E, the highest cap, had a total of only four observed taxa (moss, F. rubra, D. behringensis, and Lupinus nootkatensis) while Cap RR, the lowest cap, had a total of 14 taxa observed (including all four taxa observed at Cap E along with Achillea borealis, Agrostis borealis, Anaphalis margaritacea, Carex macrochaeta, Cerastium beeringianum, Conioselinum chinense, Epilobium latifolium, Equisetum arvense, Poa stenantha, and Rhinanthus minor). The higher diversity of taxa on the lower caps suggests that invading species are more readily established under the relatively hospitable conditions of the Crowberry Meadow Community of Amundsen (1972).

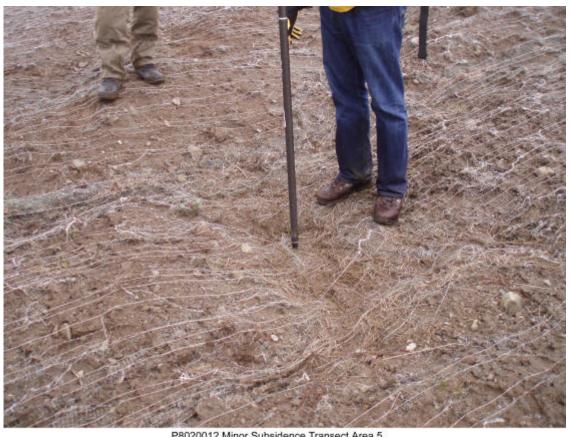
P8020012 Minor Subsidence Transect Area 5
